PRIORITIZING LEVEE IMPROVEMENTS

A Thesis

Purdue University

Master of Science in Civil Engineering

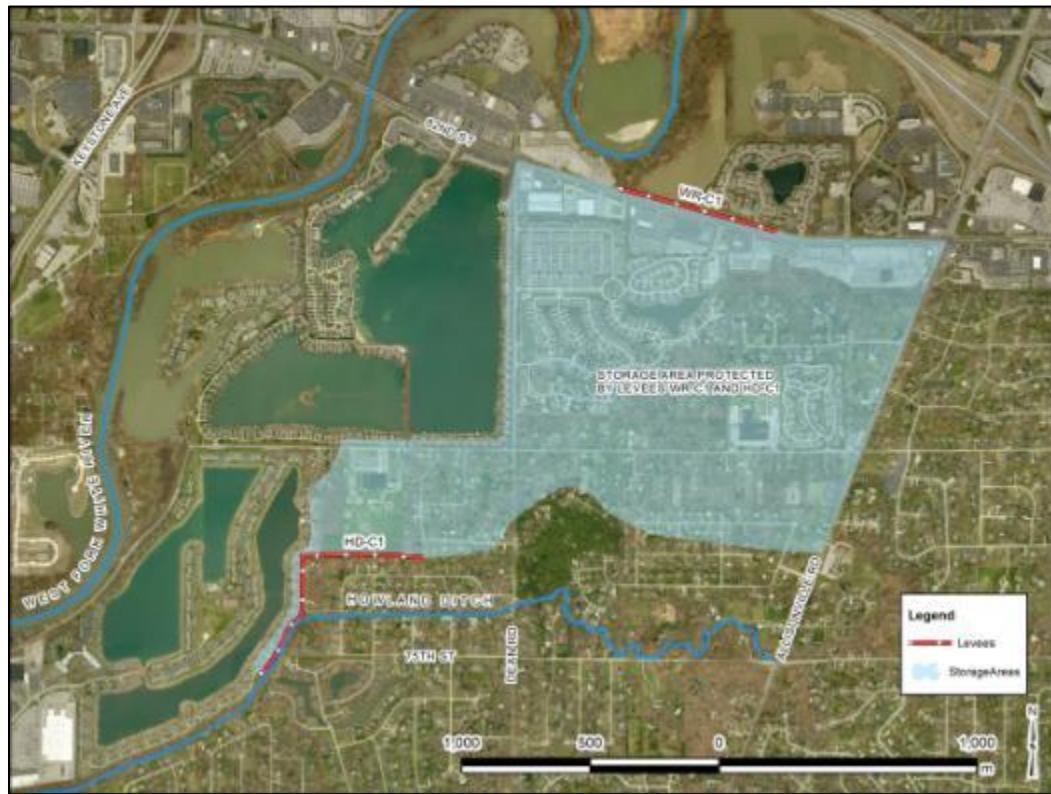
Figure 2: Urban Levee Study Area Located in Washington Township, Indianapolis, IN

The urban levee system analyzed in this study is slightly north of Broad Ripple Village, a cultural district in the north-central portion of Indianapolis, Indiana. The area is primarily residential and serves as home to one school. A small amount of commercial development also exists in the area. The contributing watershed has a total area of 3,027 square kilometers ( $\text{km}^2$ ) and is primarily agricultural, with 75.0% of the land being used for that purpose. Of the remaining area, 18.3% is urbanized, 5.3% is forested, and 1.4% covered by open water (USGS, 2010). The protected area is exposed to flood hazards from two different sources, WFK White River and

Howland Ditch. Howland Ditch is a tributary to the WFK White River, with the confluence of the streams being slightly south and west of the study area. Each flooding source has a separate levee segment which forms a line of protection. The levee providing protection from WFK White River, WR-C1, is an earthen berm with a paved roadway along the levee crest; the levee segment is approximately 640 meters in length. A second levee segment along Howland Ditch, HD-C1, spans a total of 1,006 meters, with approximately 520 meters of the total length being concrete floodwall. The remaining portion of the levee is earthen embankment. A schematic showing the location and orientation of the levees to the respective flooding sources is shown in Figure 2.

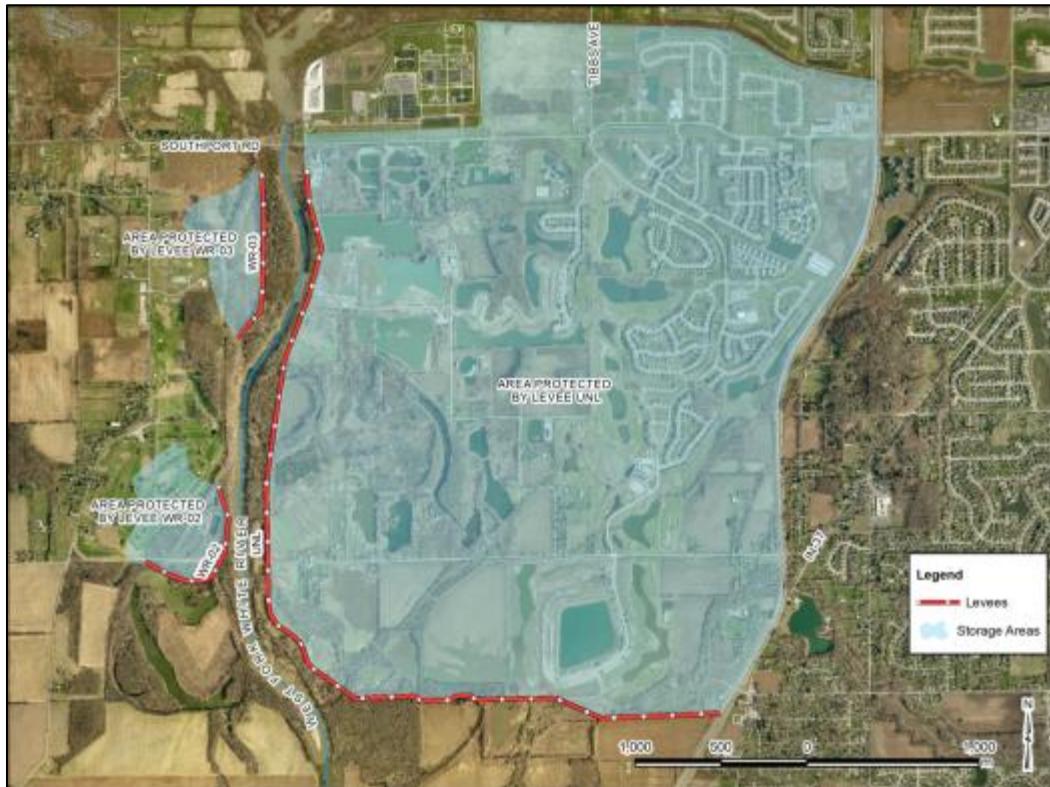
Figure 3: Rural Levee Study Area Located in Perry Township, Indianapolis, IN

The rural levee system analyzed is located on the southwest perimeter of Indianapolis, Indiana, as shown in Figure 2. The area is much more rural than the former study area; however, there are still several homes and businesses located within the protected area of the Unnamed Levee

(UNL). Levees WR-02 and WR-03 provide protection for a much smaller area which includes a very small number of buildings and a portion of a golf course. The contributing watershed has a total area of 4,885 km<sup>2</sup> and is also primarily agricultural, with 65.0% of the land being used for that purpose. Of the remaining area, 27.7% is urbanized, 5.6% is forested, and 1.6% covered by open water (USGS, 2010). The sole flooding source is WFK White River; WR-02 and WR-03 reside on the west bank of the river and UNL is to the immediate east of the river. All levee segments consist entirely of earthen berm. WR-02 runs along the west bank of the river for approximately 920 meters; WR-03 is slightly north of WR-02 and is nearly 1,000 meters in length. At nearly 21,000 meters in length, UNL is the longest levee. A schematic showing the location and orientation of the levees is shown in Figure 3.

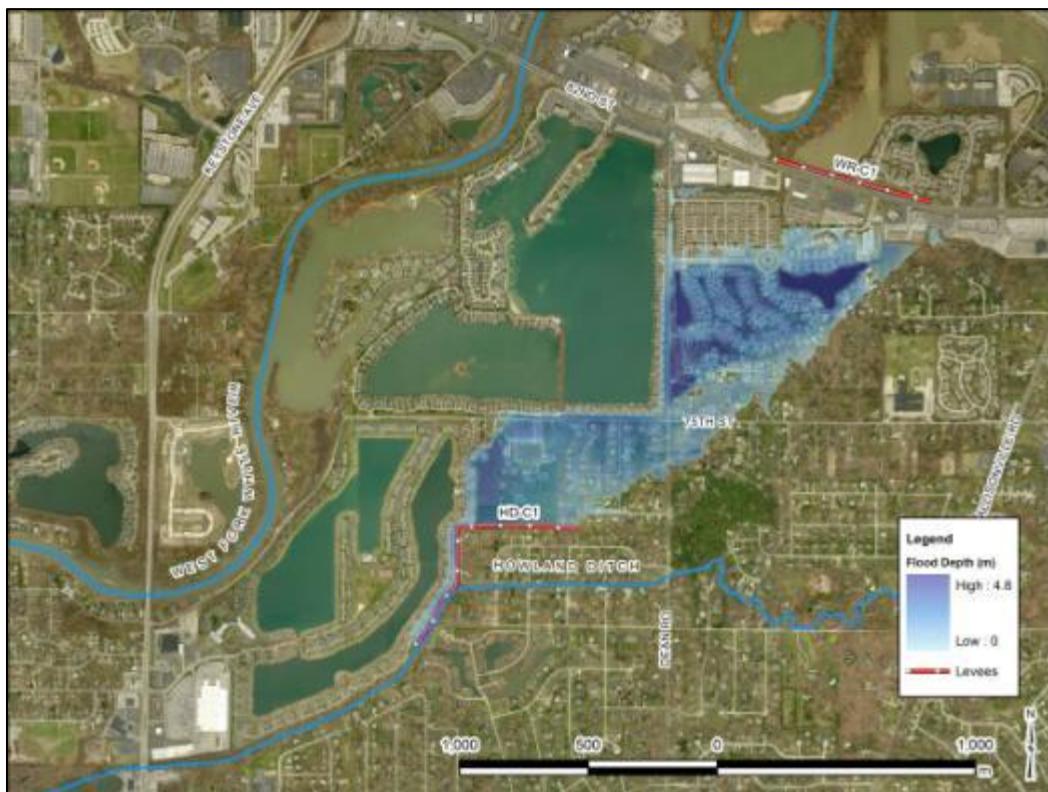
Figure 11: WR-C1 Levee Breach Depth Grid

The floodplain resulting from a breach in WR-C1 is expected to produce a floodplain that consumes 80-percent of the surface area of the storage area and 87-percent of the storage volume. The most extreme flooding within the storage area occurs in the multi-family residential area in the northern portion of the flooded area, as depicted in Figure 11. The depth of flooding within the storage area is relatively consistent with an average of 1.5 meters of depth. The continuous nature of the flooded area suggests that the assumption of perfect hydraulic connectivity is reasonable for the given application and breach scenario.

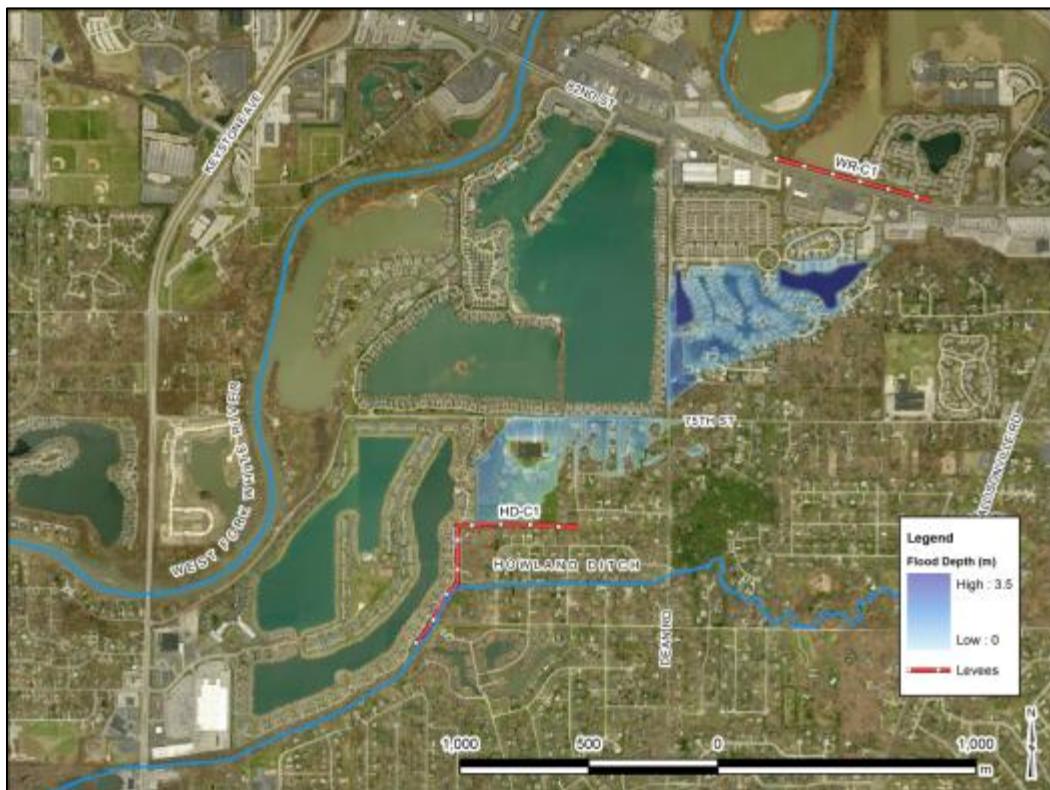
Figure 12: HD-C1 Levee Breach Depth Grid

The less severe flooding of the urban study area caused by a breach in HD-C1 produces a floodplain area that inundates approximately 42-percent of the total surface area and utilizes 46-percent of the storage volume. The low-lying residential area is once again the site of the most extreme flooding. Flood depths, shown in Figure 12, have an average of 0.9 meters. Though the floodplain area is not fully connected, it is plausible that overland flow could have allowed for substantial temporary hydraulic connectivity of the two main flooding areas.

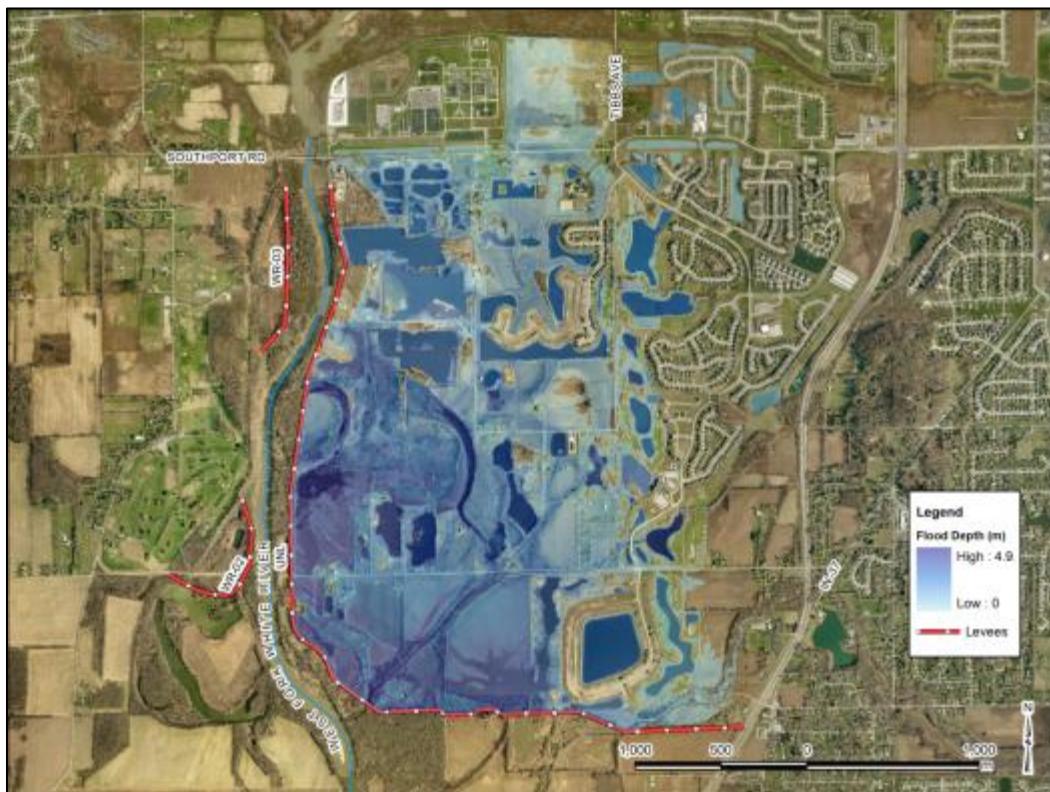
Figure 13: UNL Levee Breach Depth Grid

Flooding within the storage area behind UNL occurs mainly in the southern portion of the protected area, as the land slopes generally to the south. Agricultural lands in the south are affected most heavily by the resulting flood. The levee breach is expected to allow for 88-percent of the available floodplain area to be covered by water, and 49-percent of the storage volume to be filled by the flood. Flood waters are expected to average 1.8 meters in depth. The depth grid shown in Figure 13 reveals a flood boundary with significant disconnects; therefore the assumption of perfect hydraulic connectivity appears to be slightly less plausible for the UNL storage area.

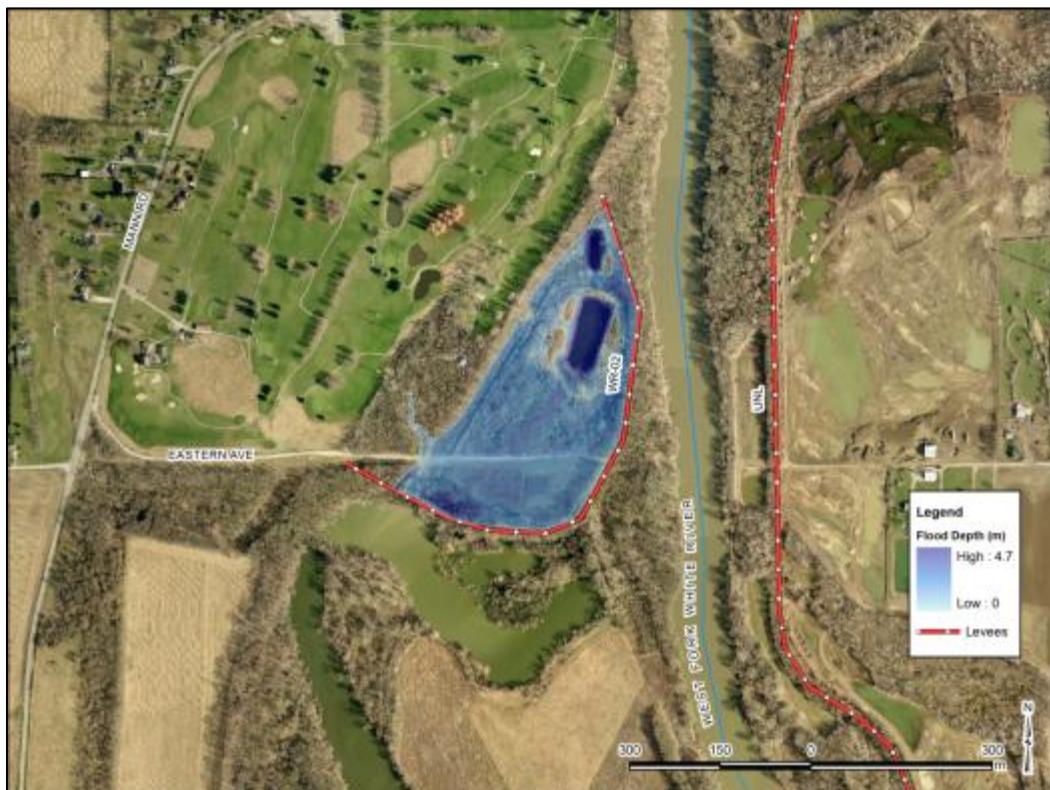
Figure 14: WR-02 Levee Breach Depth Grid

The size and relatively uniform topography of WR-02 creates a similarly uniform flood depth throughout the storage area. The average flood depth is 1.9 meters. The floodplain encompasses 98-percent of the total area, and 99-percent of the storage volume is consumed. The small size of the protected region and fact that the flood boundary nearly covers the entire area agree with the assumption of perfect hydraulic connectivity. The depth grid for WR-02 is shown in Figure 14.

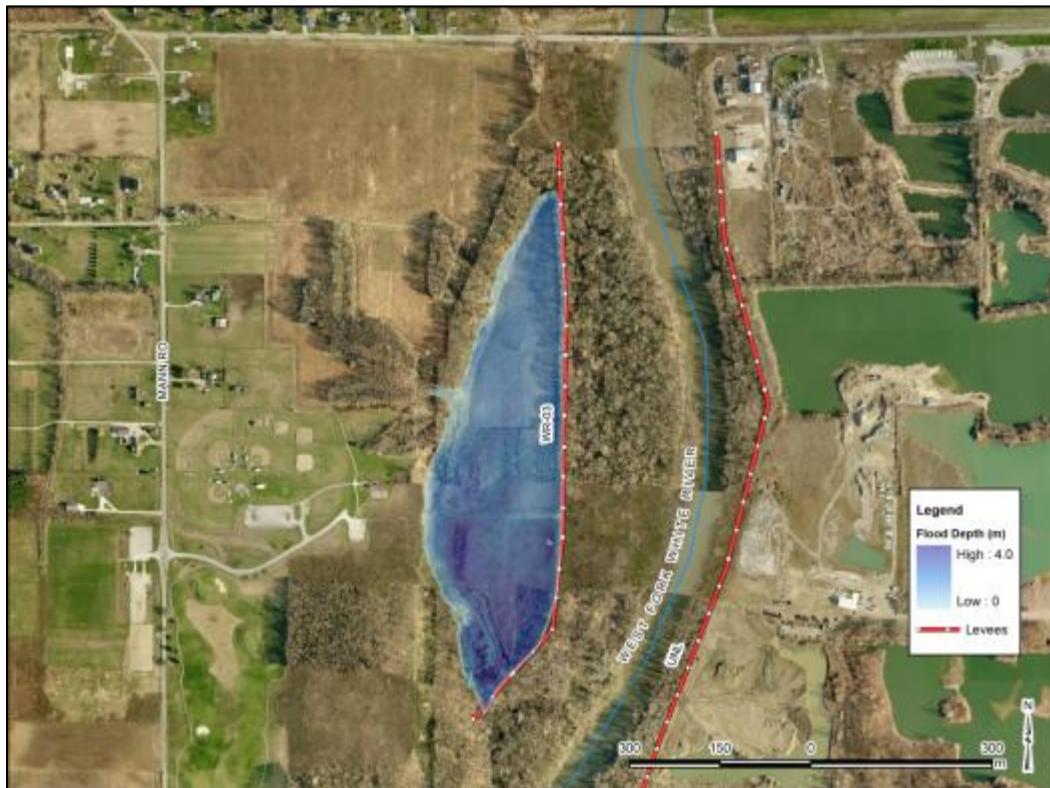
Figure 15: WR-03 Levee Breach Depth Grid

The flooded area behind WR-03 is quite similar to WR-02. The storage area is small and has consistent flood depths over the whole surface; the flood depths have an average value of 1.8 meters. The flood is expected to cover 100-percent of the total area, and occupy 100-percent of the total storage volume available. As with WR-02, the size and connectivity of the flooded area suggest that the assumption of perfect hydraulic conductivity is valid. Figure 15 shows the depth grid for the flood resulting from a levee breach in WR-03.

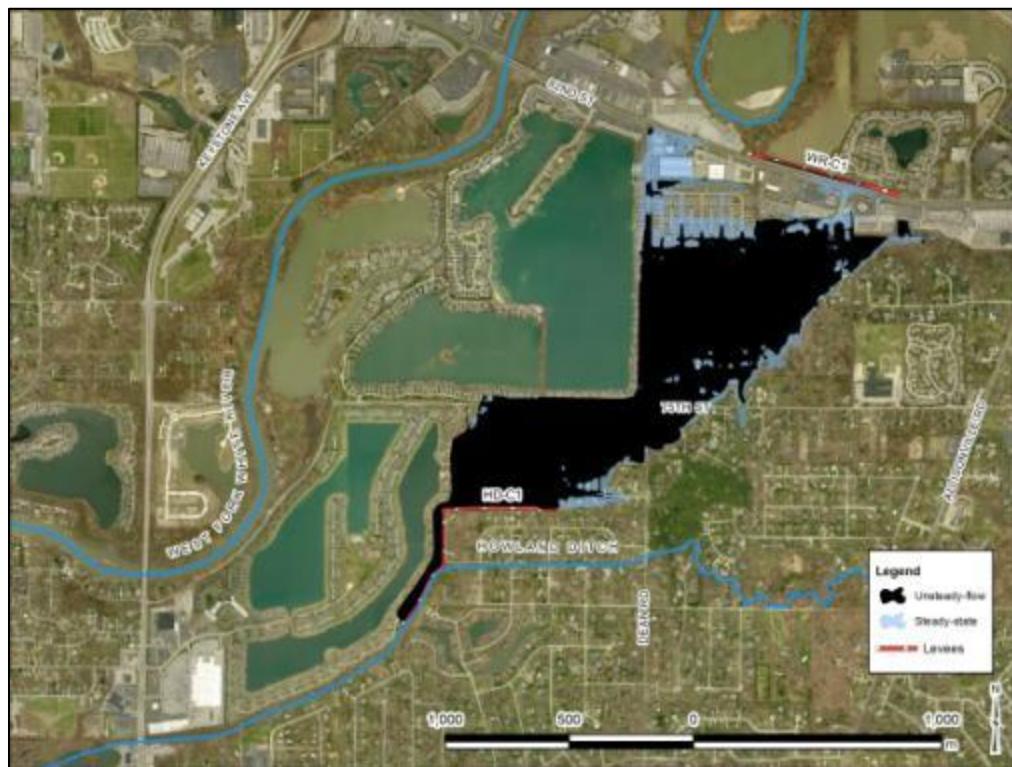
Figure C.2: Unsteady-flow vs. Steady-state Floodplain Boundaries for WR-C1 Levee Breach
